RISK

MODULE 3

BUILDING ENVIRONMENT 2
ASBESTOS

MAXIMISING MINISTRY BY MINIMISING HARM

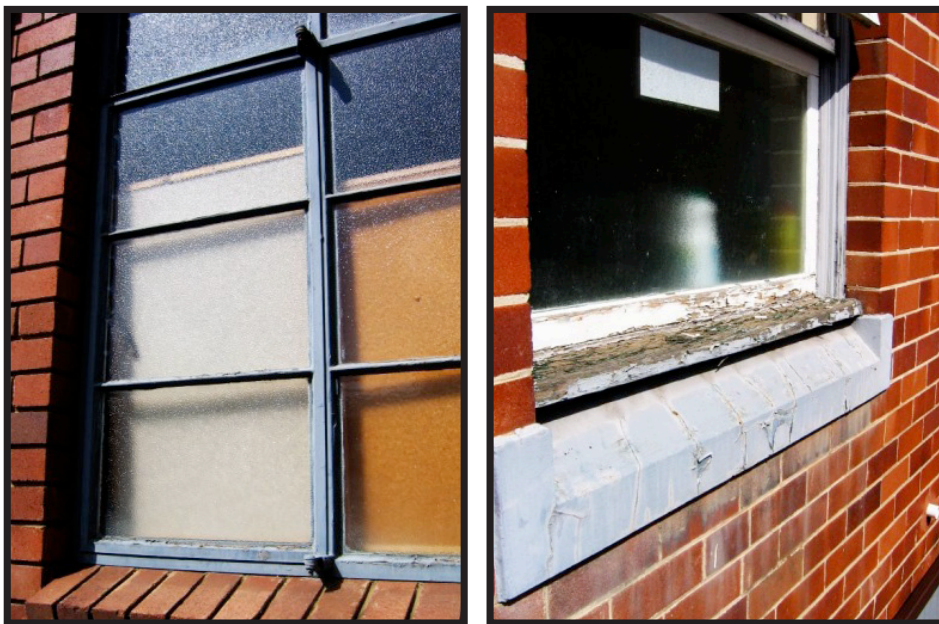
Lead in paint is a health risk as the paint can enter the body through contact and frequently with children through ingestion. If the paint is removed and not captured it can contaminate building surfaces, the soil and be carried off during rainfall into natural waterways where it accumulates as sediment. Examples of lead based paints that need removal are shown in these photographs.

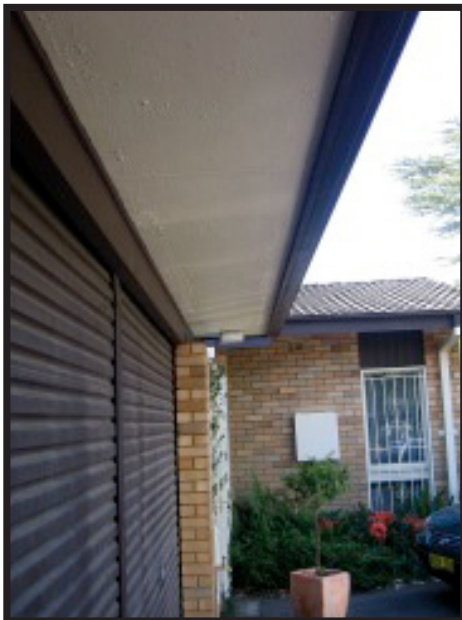
Asbestos cement surfaces can have the paint deteriorate and either bubbles form or the paint begins to flake. The repainting of the surface requires the damaged paint to be removed. Examples are shown below.

The danger in removing the damaged paint surface is in abrading/damaging the asbestos cement surface and causing the release of asbestos fibres. There is also the danger on buildings painted prior to 1976 that the paint may contain lead. If this is known or even suspected then refer also to Work Practice Guide No.3.

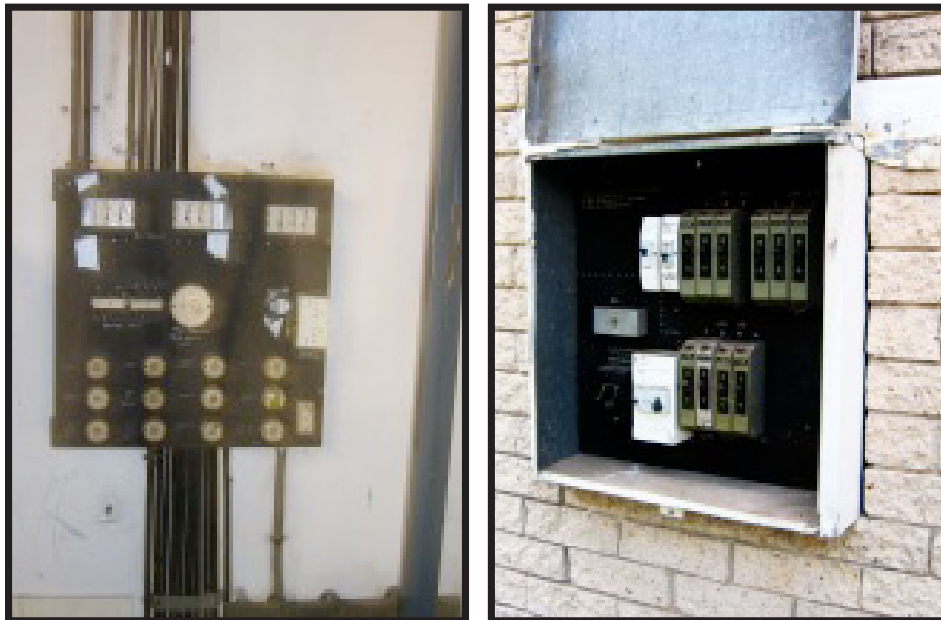
Electrical panels frequently have boards that contain asbestos fibres. Examples are provided below.

These boards need to have asbestos warning labels attached. This procedure assists in guiding your management of this issue.

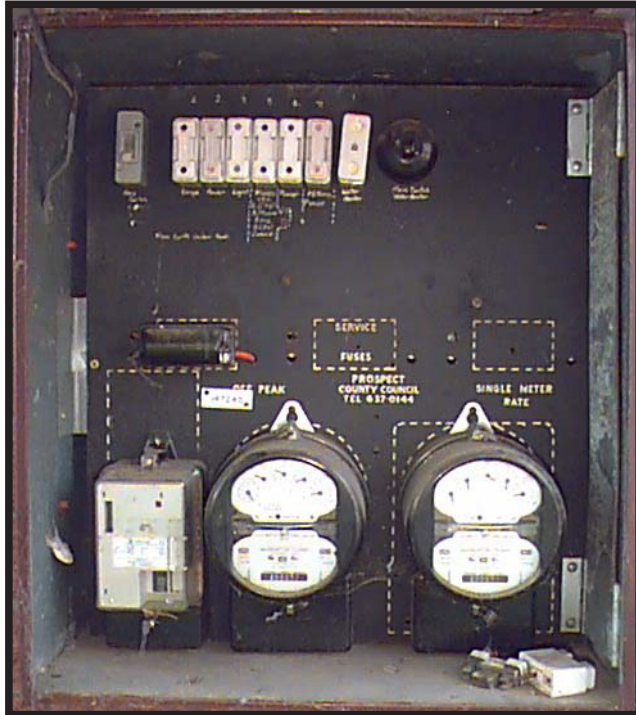
ANNEXURE 1

This photograph is an example of an asbestos-based electrical backing board in a typical domestic installation. Note the dust in the bottom of the cabinet and on the fittings. All dusts inside the cabinet are assumed to be contaminated with asbestos.
